# Project Profile

## Hudson Hospital Diagnosing the issue.

**Project:**  
Custom Polish and Stain

**Location:**  
Hudson Hospital  
Hudson, WI

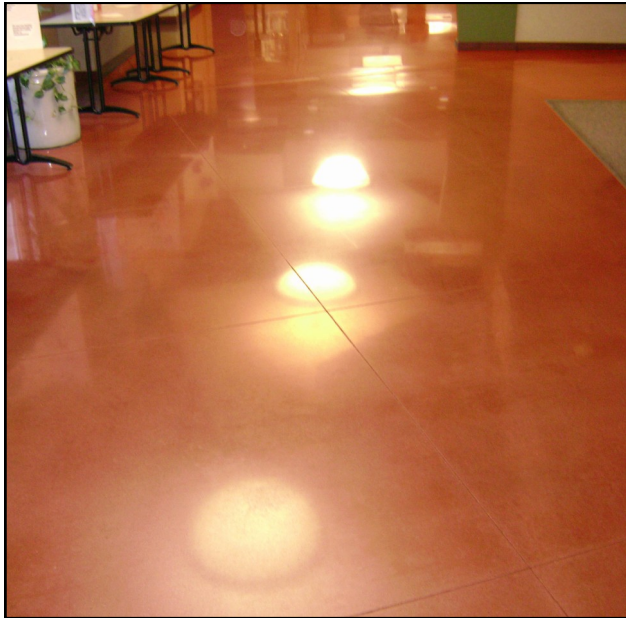
The Hudson Hospital was enduring discoloring and blistering from a colored urethane coated flooring system. This type of flooring was not the right system for the Hudson Hospital because of vapor drive issues. The moisture was pushing up through the floor while the Urethane blocked the natural vaporization and simply not allowing it to breathe and causing deformities.

**Problem:**  
Vapor and moisture caused discoloration and blistering

The best solution was to grind the Urethane and polish the floor. The hospital

liked the color that it had, so we matched the flooring with a colored dye similar to the original Urethane.

Custom polishing the floor now allows the Hudson Hospital flooring to easily breathe which doesn't block in the moisture. It has a great sheen, reflectivity, and color that really enhances the inside aesthetics. The best thing about the floor is that if you walked into that hospital today, it looks exactly as it did when we first finished the project five years ago.

**Solution:**  
Polishing is a breathable flooring option. The Urethane was ground off and the floors were dyed and polished for sheen.
