# Project Profile

## YMCA Floor Restoration

**Project:**  
Custom Polishing

**Location:**  
YMCA  
2211 Vine Street  
Hudson, WI 54016

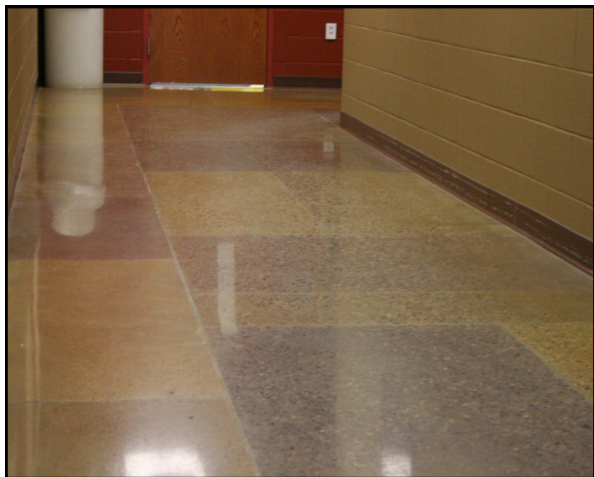
The YMCA carpets were worn-out and had visible stains and water damage which hindered the overall appeal of the building. A custom polished floor deemed the best solution for the YMCA due to its durability and ability to save on maintenance costs.

During the preparation of the floor, we found many challenges once the carpet was removed. There were uneven heights in the flooring due to separate foundation floors and random cracking. To fix this base problem, cracks were routed out and filled with Polymer modified grouts and structural cracks were filled with Epoxy to bond slabs back together.

To enhance the appeal of the flooring, faux joints were cut in and grouted to simulate an ashlar slate pattern in the flooring and individual ashlar squares were custom stained to add dimension. The YMCA now has a durable floor that looks great and it's easier to maintain.

**Solution:**  
Remove carpet-  
ing and adhe-  
sives. Grind,  
stain, and pol-  
ish floors.

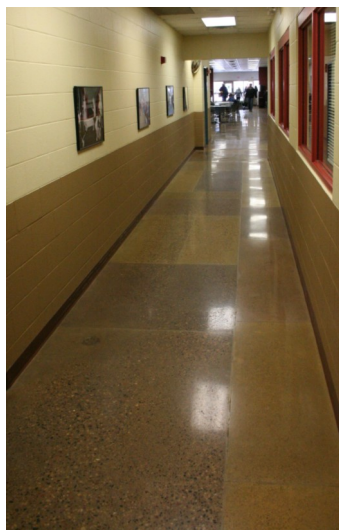
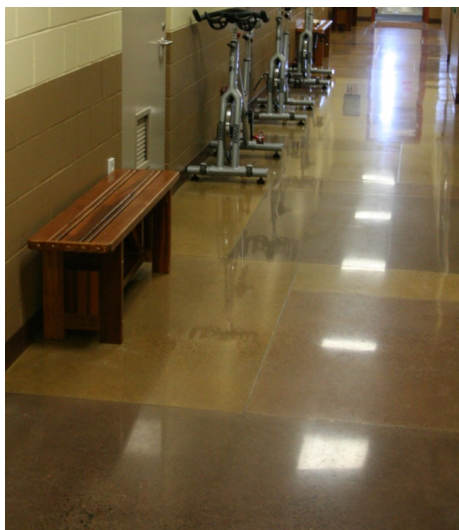
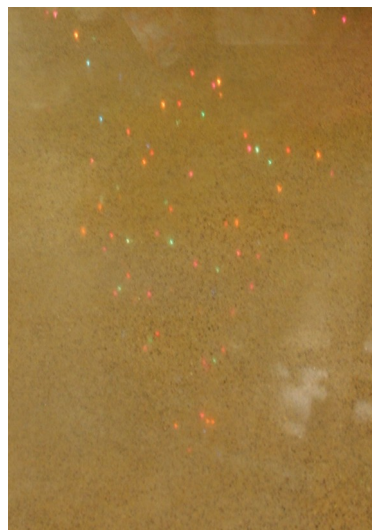
**Problem:**  
Old, worn-out  
carpet with  
stains and water  
damage

**Results:**  
Beautiful, easy  
to maintain  
flooring with  
no sealers or  
waxes. Does  
not need to be  
covered with  
mastics, carpet,  
or tiles.
